WIKTOR WCIŚLIK<sup>1</sup>  
PAWEŁ KOSSAKOWSKI<sup>2</sup>  
Kielce University of Technology  
<sup>1</sup> e-mail: wwcislik@tu.kielce.pl  
<sup>2</sup> e-mail: kossak@tu.kielce.pl

# CARRYING CAPACITY ASSESSMENT AND STRENGTHENING OF REINFORCED CONCRETE STRUCTURES OPERATING IN CHEMICALLY AGGRESSIVE ENVIRONMENT

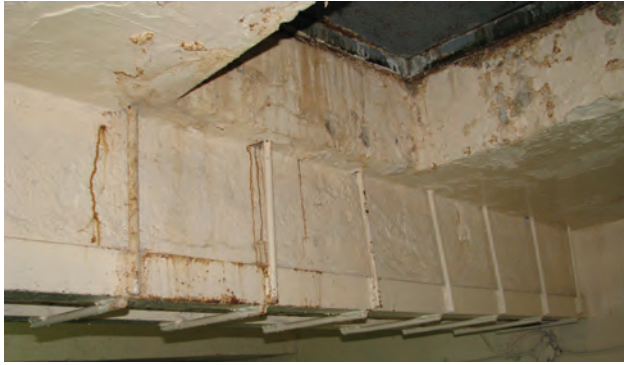
Floor slabs showed considerable degradation manifested as concrete hairline cracks and cracks, and also chipping and scaling at the sites of member repairs. Some ribs and spandrel beams had been previously strengthened by installing steel elements (Fig. 2). The repair works proved ineffective, which was indicated by multiple cracks and crumbling of the mortar used for levelling and reinforcement protection against corrosion. Chemical corrosion of concrete and reinforcing steel was also observed. At many sites, rusty stains were found, which indicate advanced reinforcement corrosion in the reinforced concrete members.

Fig. 2. View of corrosion of the floor and floor beams at the level of +4.20 in part B

Additionally, white efflorescence was found, which results from calcium compounds being washed out of concrete. All those damages are related to the kind of production processes in the plant, where structural members are exposed to aggressive chemical environment, mainly chlorides.

Konstrukcja płyt stropowych, na których zaobserwowano zarysowania i spękania betonu, a także odpryski i odspojenia w obrębie miejsc napraw elementów charakteryzowała się znaczną degradacją. Część żeber i rygli ram została poprzednio wzmocniona poprzez zamontowanie elementów stalowych (rys. 2). Wykonane naprawy okazały się nieskuteczne, o czym świadczą liczne spękania oraz wykruszenia zaprawy wyrównującej i zabezpieczającej zbrojenie przed korozją. Zaobserwowano również korozję chemiczną betonu i stalowych elementów wzmacniających. W wielu miejscach wystąpiły rdzawe nacieki świadczące o zaawansowanej korozji zbrojenia elementów żelbetowych.

Because of damages and insufficient resistance of many members that posed a considerable safety risk to the building users, a decision was taken to instantly unload the floor structure and to strengthen it. The floor structure (beams and slabs on the bottom side) were renovated using the Deitermann's PCC concrete repair system.

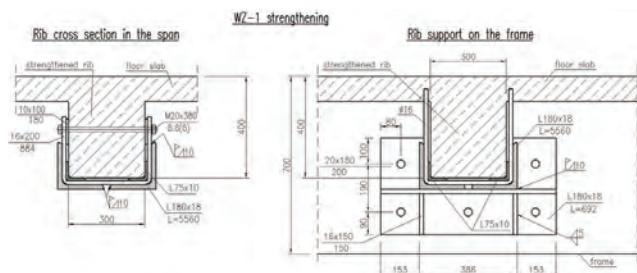
Figure 3 shows the strengthening of the floor beams in part B of the building at the level of +4.20.

Fig. 3. Strengthening WZ-1 of the floor beams of part B at the level of +4.20

Beam strengthening was designed to include additional load carrying components, namely two L180x18 equal angles installed underside.

Lankwitzer corrosion protection paint was applied to the steel structure. The epoxy and polyurethane material is suitable for corrosion environment (C4) and expected long lifetime of the structure (H).
