EWA ZENDER-ŚWIERCZ¹
JERZY Z. PIOTROWSKI²

Kielce University of Technology
al. Tysiąclecia Państwa Polskiego 7
25-314 Kielce, Poland

THERMOMODERNIZATION A BUILDING AND ITS IMPACT ON THE INDOOR MICROCLIMATE

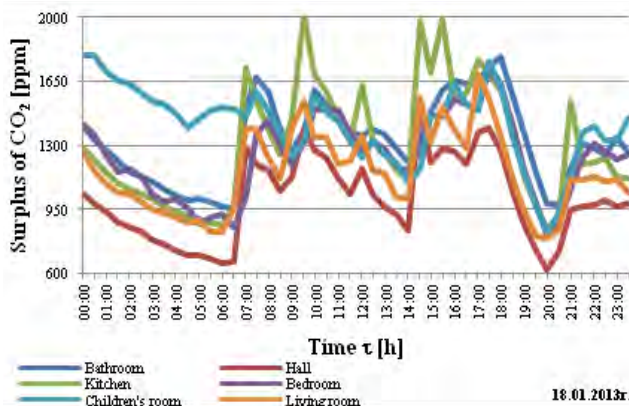
Fig. 1. Changes of the concentration of carbon dioxide in time for different rooms

Figure 1 shows the course of the excess carbon dioxide in time for one day in different rooms. The highest values were observed in the nursery, the lowest

were in the hall. High values of CO₂ concentration in the kitchen occurred during daylight hours when the gas-stove was used. In each of the rooms the limit of carbon dioxide concentration (700 ppm above the value in ambient air [1]) was exceeded.

The measurement was done with the windows closed. The micro-opening did not result in improvement of the microclimate. Not till then when the windows were opened the analyzed parameter were lowered. The observed results are the same as those obtained in other studies presented in [3].

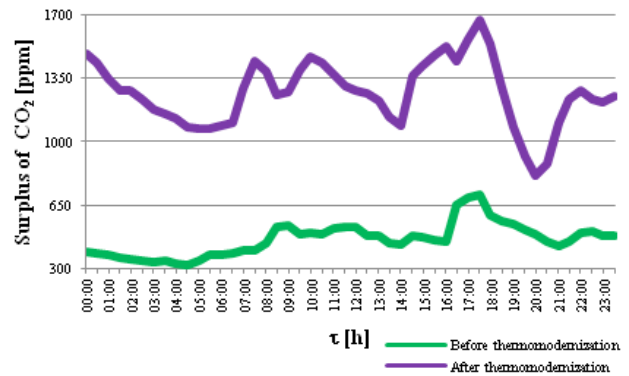
Fig. 2. Changes of the concentration of carbon dioxide in time before and after thermomodernization

It should be noted that the last change amendment introduced in the building was sealing the roof without thorough analysis of the work of ventilation. The changes made in the previous years of operation of the building for example that the sealed window frames were mounted previously were not also taken into account. It is supposed that the installation of new windows has caused reduction of the inflow of air into the facility, but had not caused visible changes in the functioning of the flats. This can be seen when analyzing the Figure 2, which contains course of changes in CO₂ concentration before and after the thermomodernization. Despite the tight joinery surplus analyzed parameter above the value in external air was lower than the limit value [1].

After sealing the roof we see a large increase in the analyzed parameter that throughout the period of measurement exceeds the limit value (for comparison, the results published in [4]).

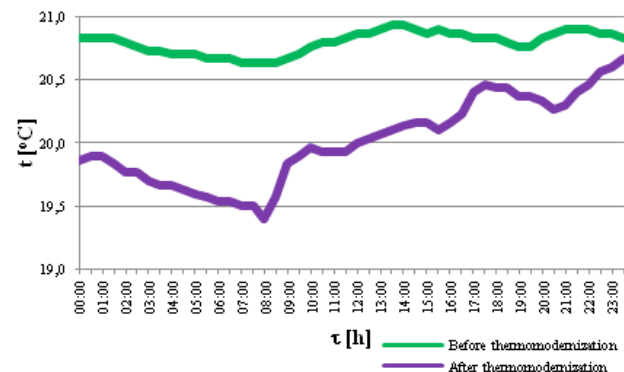
Fig. 3. Changes of the interior temperature in time before and after thermomodernization

Because the fungus on the exterior walls in bedroom, children's room and the living room was observed the tenants began opening the windows what resulted in drop in internal temperature (Fig. 3). The temperature after thermomodernization was lower about 1K than the value of parameter before sealing the roof.

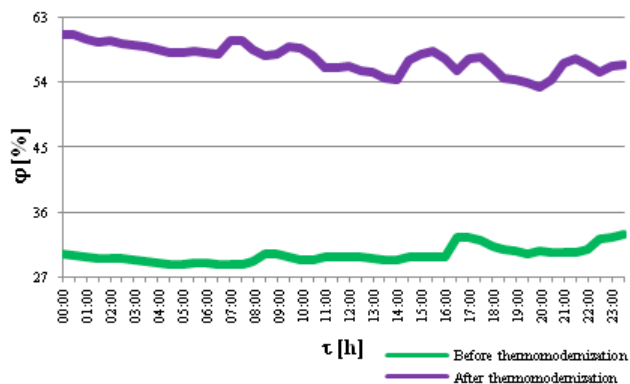
Fig. 4. Changes of the interior humidity in time before and after thermomodernization

Also the internal humidity was analyzed. Figure 4 exposes an increase of the analyzed parameter after sealing the roof. Taking into account the temperature and humidity of the internal air (with closed windows or micro-opened windows) using the Mollier's Graph, the dew point was determined. The comparison of this value with the temperature of the external wall showed crossing the dew point which means that moisture will be condensing on the wall surface. Hence fungus occurring on the wall.

Comparison of changes in humidity in time for various rooms showed the highest values of the parameter in the rooms where the only source of moisture were people. Air humidity in the kitchen and bathroom was lower than in the rooms. Therefore, the increase of the analyzed parameter was not due to the use of facilities.
